Limited Visual Dam Safety Inspection Summary Report

MA-138

Kahakapao Reservoirs

Limited Visual Dam Safety Inspection Conducted on: 05 April 2006

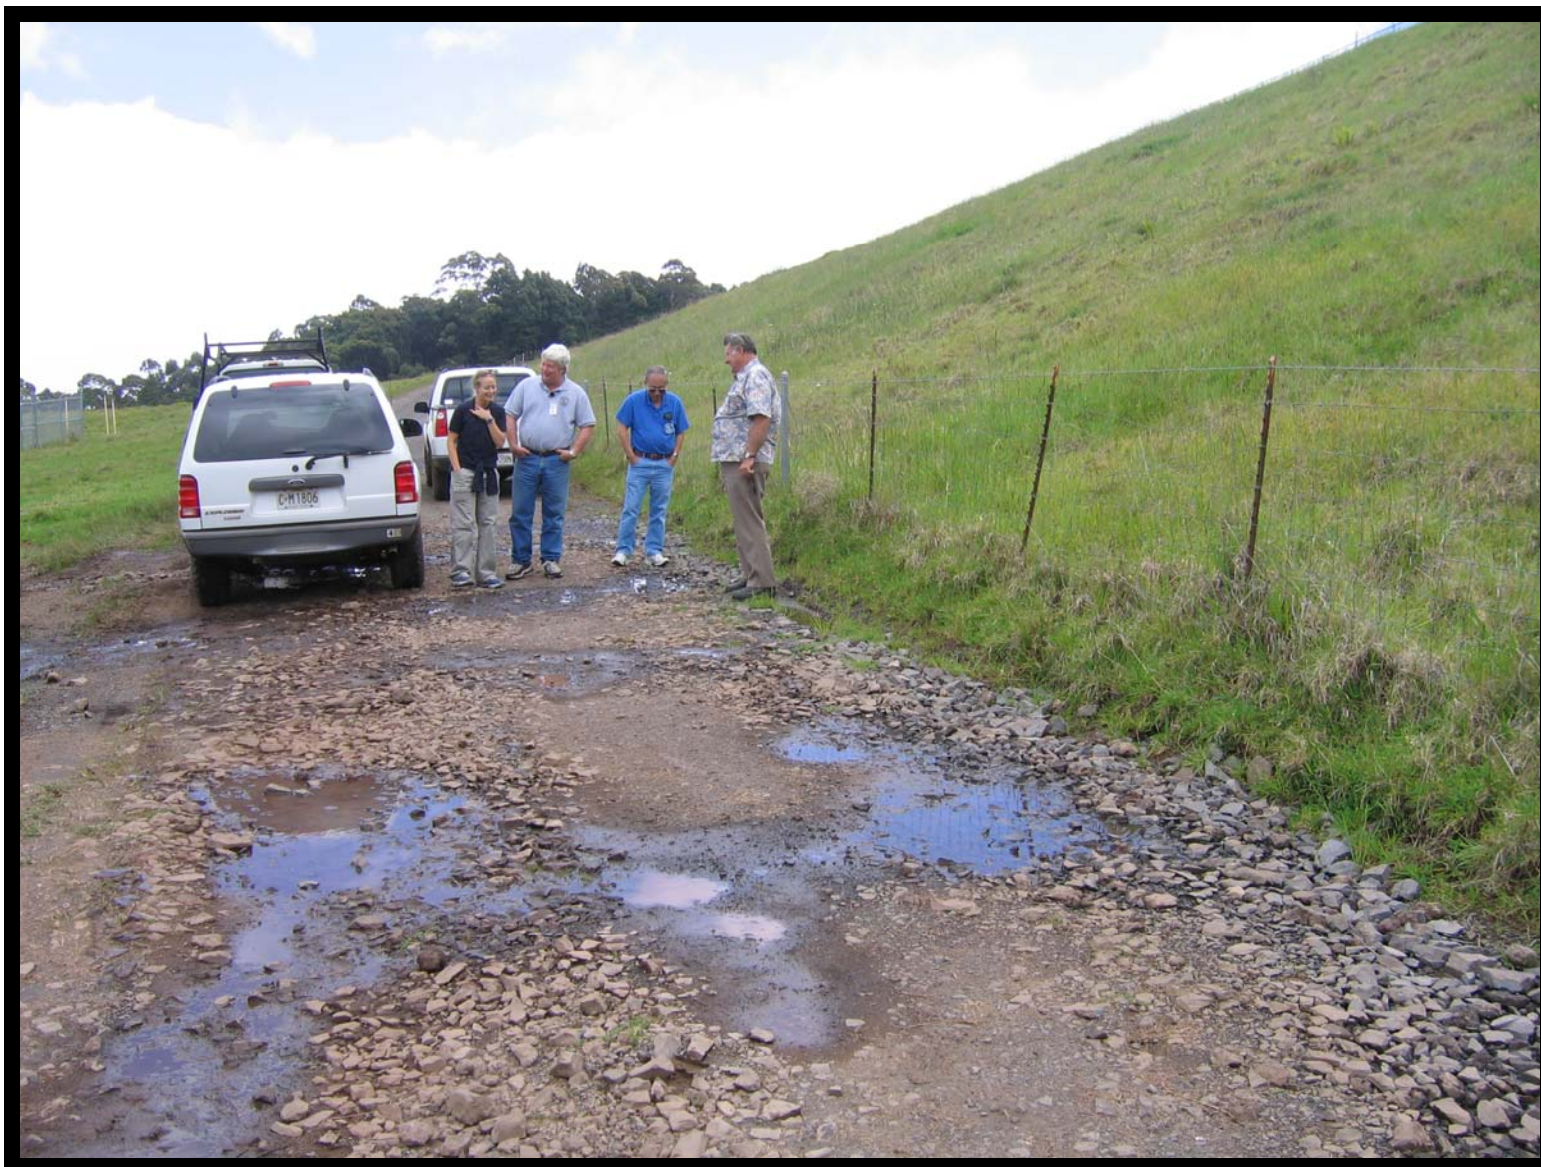
The downstream slope was approximately 1 on 2.5 slope and consisted of low ground cover. Sinkholes were not observed on the downstream slope. Seepage was observed and located near the left end of downstream slope at the toe. The flow is very minor that was reported to be spring water prior to construction. Additionally the seep is located near the soil bedrock interface based on construction layout at the site. The seep was clear. The seepage is very minor and likely to be unrelated to impoundment.

138 View of downstream seep at left corner, reported to be from rock interface

- a. The downstream slope appeared to be in satisfactory condition, no corrective actions are required at this time.
- b. Seepage was observed. Monitor and report and change in current condition.

Continue to monitor known seep and report any significant changes in flow.

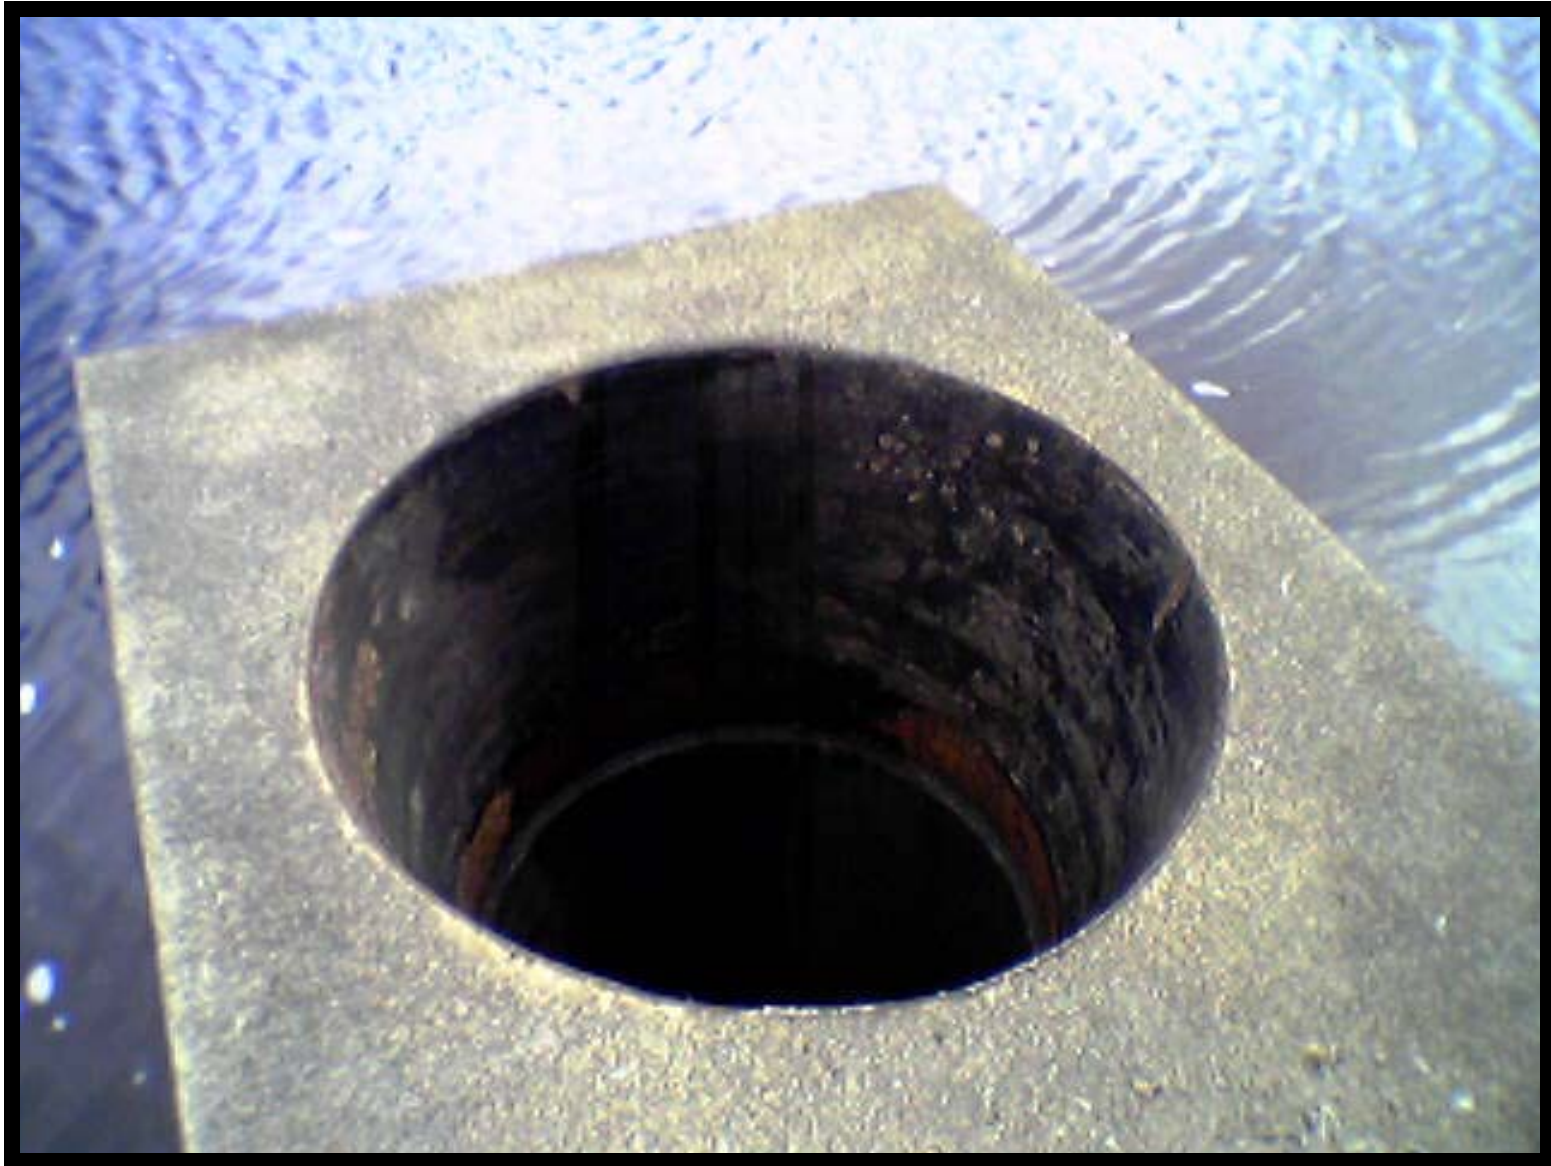
This spillway consisted a dual morning glory (3 feet in diameter), one in each reservoir. The spillway approach was clear. There was no erosion observed where the spillway exits to daylight.

138 Morning glory spillway - One of two morning glory spillways that exit to diversion ditches.

- a. The Spillway appeared to be in satisfactory condition, no corrective actions are required at this time.

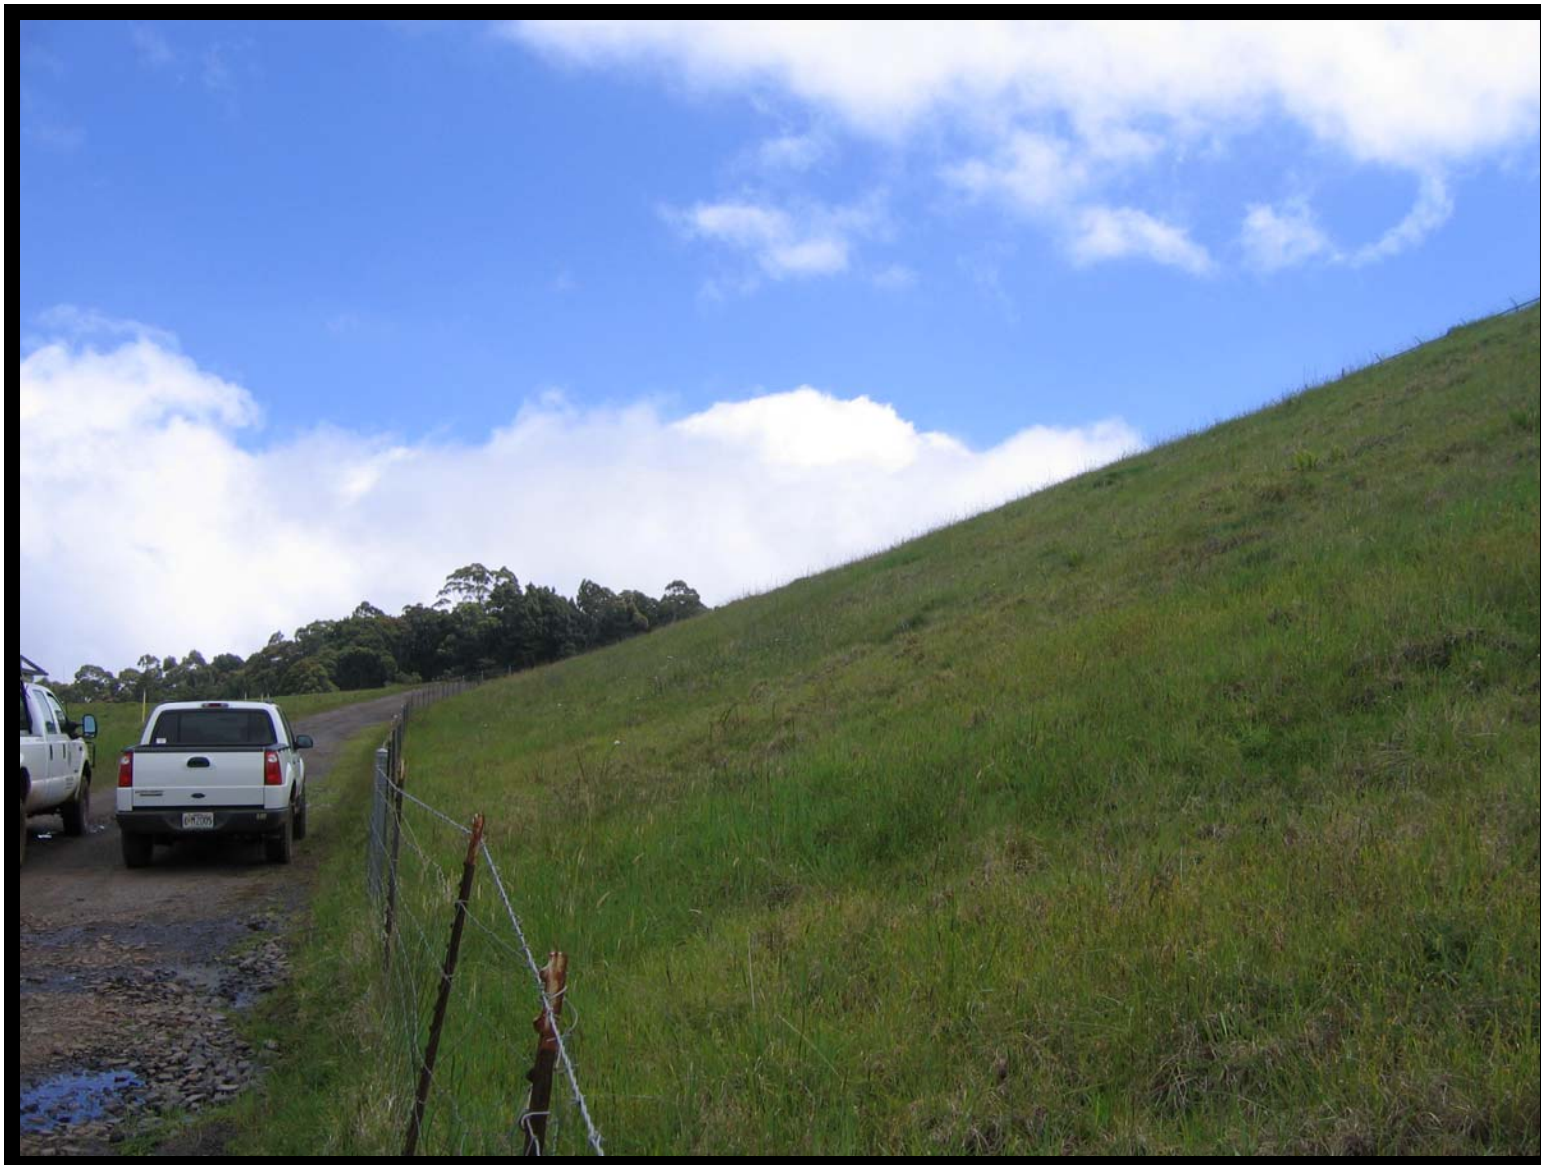
138 Downstream slope and cover looking to right end of reservoir.
